RAILWAY INVESTIGATION REPORT

R05Q0010

MAIN-TRACK DERAILMENT

CANADIAN NATIONAL

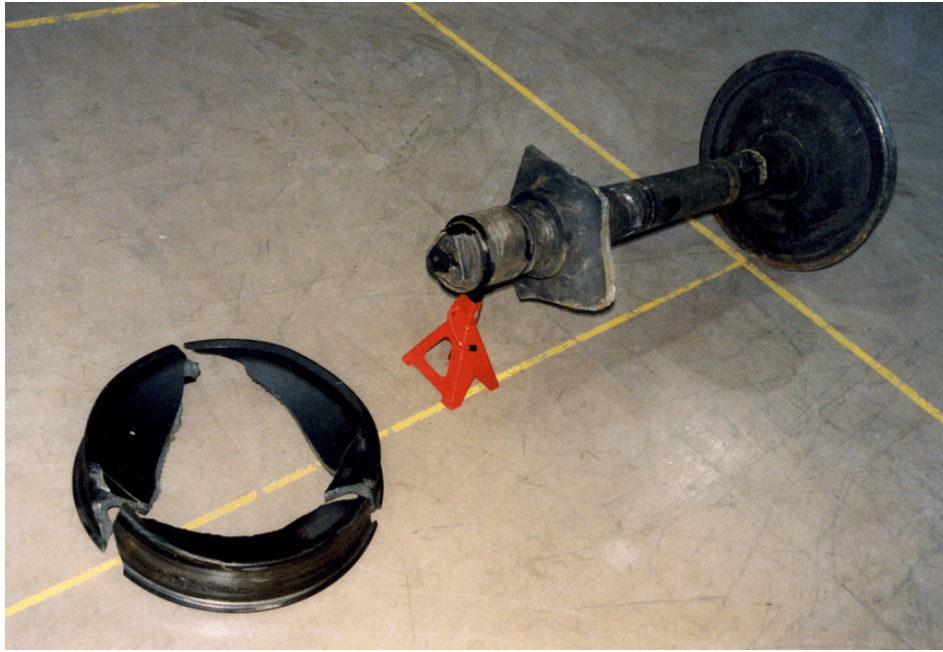
Examination of the derailed cars showed that car WC 65061 had lost its rear truck. The truck was directly westward of the pile-up of derailed cars. The wheel plate of wheel L2¹ was fractured; part of the plate remained attached to the axle and the wheel rim broke into three main pieces of equal length and a small fragment (see Photo 2).

Photo 2. Axle LR2 and pieces of wheel L2

The metallurgical analysis of the wheel plate samples showed the presence of microporosity caused by dissolved hydrogen bubbles that were trapped when the wheel was manufactured. The voids were spread across the entire surface of the wheel plate. The degree of porosity was relatively low and could not be detected by the conventional detection devices used in non-

destructive tests. The degree of porosity would not have caused the wheel to be rejected because porosity is not standardized in the industry. Three fatigue cracks 10 to 15 mm long in the external part of the wheel plate spread from voids.

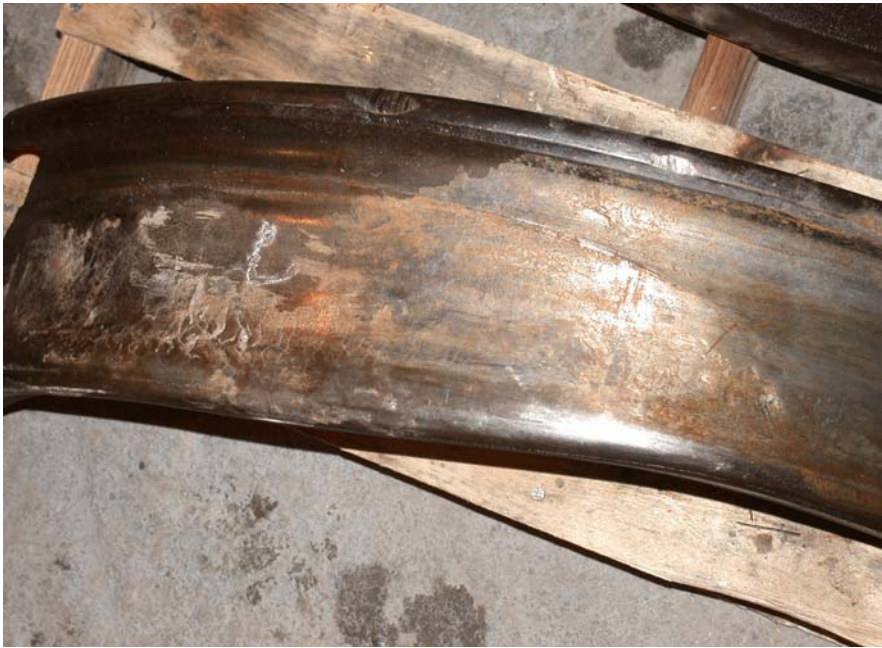
The wheel was oval, and its running surface had a flat that was crushed by 0.38 inch over a length of 22 inches. This same area displayed plastic deformation (see Photo 3) that reached up to one inch in width (the width of the surface went from a nominal size of 5.72 inches to 6.75 inches).

Photo 3. Plastic deformation of the running surface on wheel L2

It also exhibited shelling in the deformed area, but the shelling did not exceed the AAR allowable limits. The opposite wheel on the axle also had a plastic deformation about 0.23 inch wide and 5.5 inches long. There were no signs of discoloration or burn on the running surface of the wheels (see Photo 3).

Because the wheel was broken into several pieces, it was not possible to take its out-of-round measurements. However, if the flattened surface of the wheel (0.38 inch) is plotted against the out-of-round values, the impact load caused by wheel L2 can be estimated by referring to a CN study conducted in 1994-1995. According to that study, which establishes a correlation between the WILD data and out-of-round measurements, the impact load generated by an out-of-round of 0.38 inch would be greater than 200 kips.

surface illustrate this aspect and show that wheel L2 had been subjected to excessive stresses caused by impact loads. These impact loads are amplified by the very deformation that they cause with every rotation of the wheel. The effect of the impact loads amplified by the wheel's plastic deformation, the low ambient temperature and the porosity observed in the wheel plate led to the initiation and propagation of the cracks that caused the failure of the wheel on car WC 65061.
